**Docket No. 217 – Development and Management Plan Inspection**

Northeast Utilities Service Company Certificate of Environmental Compatibility and Public Need for the construction of a 345-kV electric transmission line and reconstruction of an existing 115-kV electric transmission line between Connecticut Light and Power Company's Plumtree Substation in Bethel, through the towns of Redding, Weston, and Wilton, and to the Norwalk Substation in Norwalk, Connecticut.

**Date:** July 5, 2006

**Location:** 345kV Underground Route

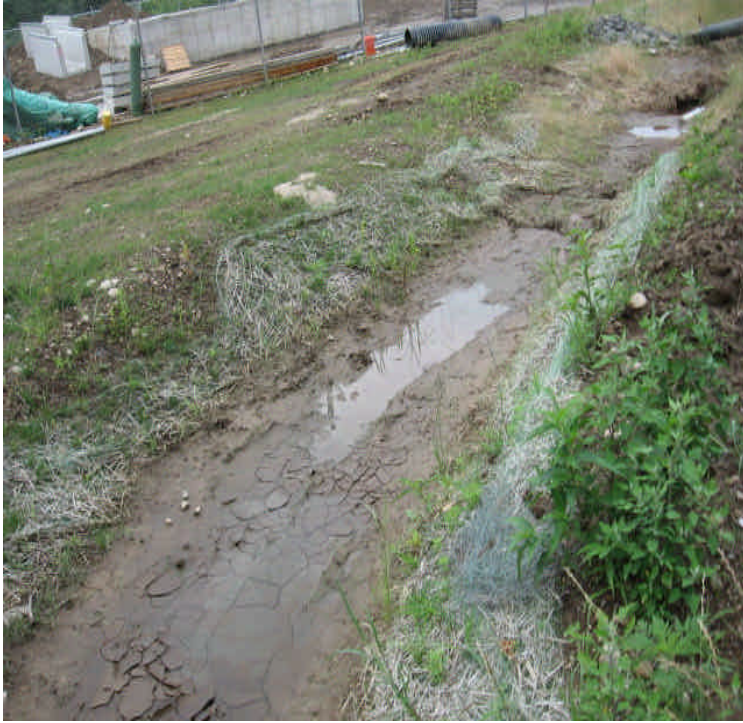
Areas of Inspection	Observation	Recommended Action	Corrective Action
Norwalk Junction	<p>the sides of the roadway and down the recently constructed slope near #98, which was not project related. 6/29-7/5/06</p> <p>- Significant sediment had accumulated in the swale as a result of dewatering. 7/5/06</p>	<p>project and should be evaluated by town engineers or DPW. 6/29-7/5/06</p> <p>- The swale had been cleaned once but it needs to occur again. 7/5/06</p>	- N/A
Adjacent Wetlands and Waterways	<p>-The wetland area to the east of the HDD basin had some turbid flow as a result of the rain but remains well restored. 7/5/06</p> <p>-Adjacent areas of wetland were restored around the HDD site. 6/14-7/5/06</p>	<p>-Continue to monitor until the area has stabilized. 6/20-7/5/06</p> <p>-Some wetland seed mix was placed and the areas can revegetate naturally. 6/20-7/5/06</p>	<p>- N/A</p> <p>-N/A</p>
Staging, Storage, and Parking Areas	<p>- The equipment storage yard on the property south of the Rt. 7 &amp; 107 intersection was mostly contained. 1/26-7/5/06</p> <p>- Disturbance is mostly due to landowner activities. 3/15-7/5/06</p> <p>- Debris was being piled here as well but efforts will be made to clean up. 6/29-7/5/06</p> <p>- The storage area along Rt 7 across from Old Highway Rd is still in use. The larger stockpiles were no longer noted 7/5/06</p> <p>- The racquet club storage yard has a pile of sandbags stored here. Stormwater had been seen running to the swale on site. 6/7-7/5/06</p> <p>- Equipment and materials are also being stored off Rt</p>	<p>- In general, materials should be placed appropriately in storage areas or immediately adjacent to work each night. No potentially spillable materials should be left behind. Equipment should not be placed near resource areas.</p> <p>- Even though this is an active site, provide good housekeeping and remove debris when feasible. 5/4-7/5/06</p> <p>- The area is fairly well contained but control disturbed soil if necessary. Continue good housekeeping here. 7/5/06</p> <p>- Install haybales at the culvert within the swale in an attempt to filter run-off. 2/2-7/5/06</p> <p>- Keep areas contained and avoid encroachment</p>	<p>-N/A at this time</p> <p>-May need attention</p> <p>- Needs attention</p> <p>-Continue to</p>

**345kV (Norwalk Junction)** Photo on the left shows where significant sediment accumulation was noted in the NJ swale from dewatering. This should continue to be removed. (Old Danbury Rd)  
Photo on the right shows where the recent rain washed sediment over the silt fence. 7/5/06

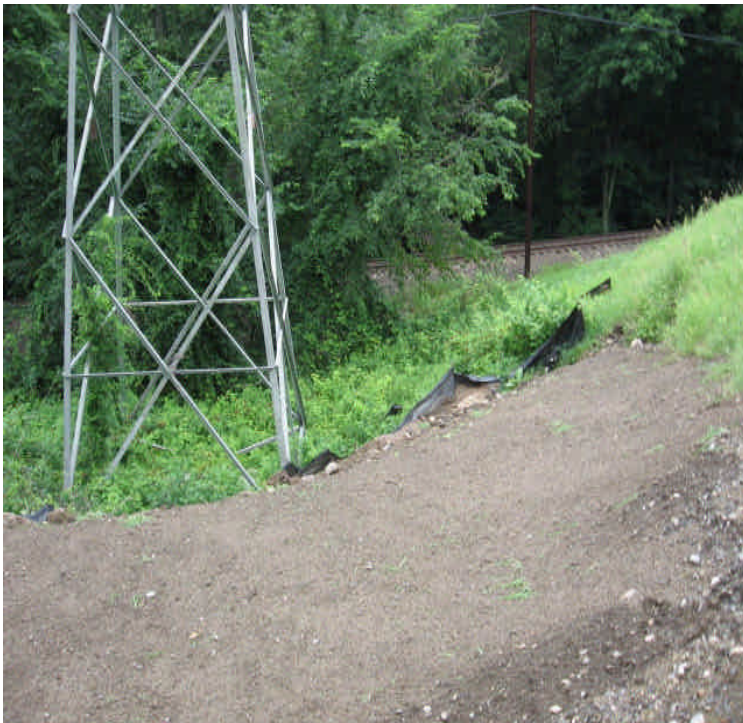
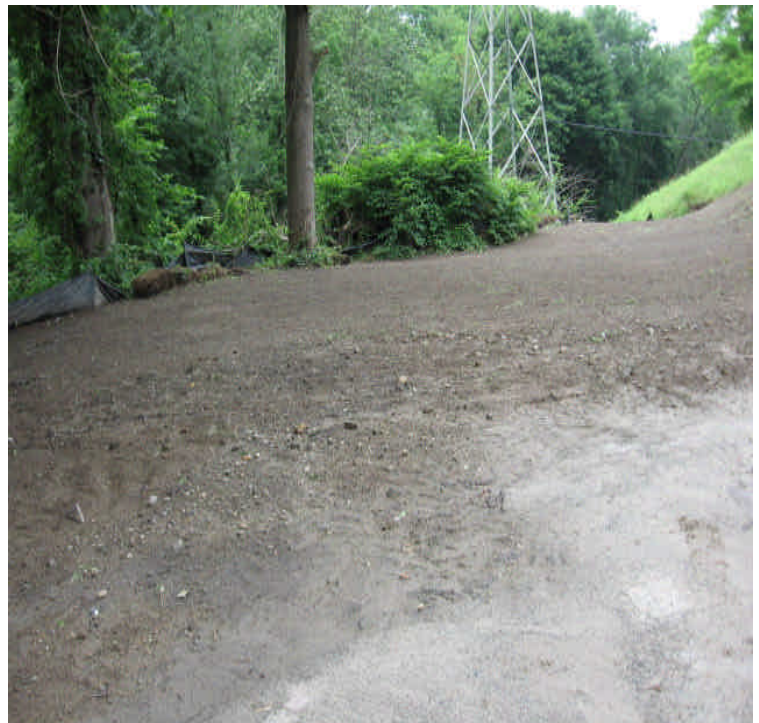
**(Old HDD exit point):** Both photos show the area at the HDD exit point near the limousine service on Rt 7. The area was graded and seeded and the erosion at the slope was repaired with some boulders and soil. Continue to monitor for stabilization 7/5/06

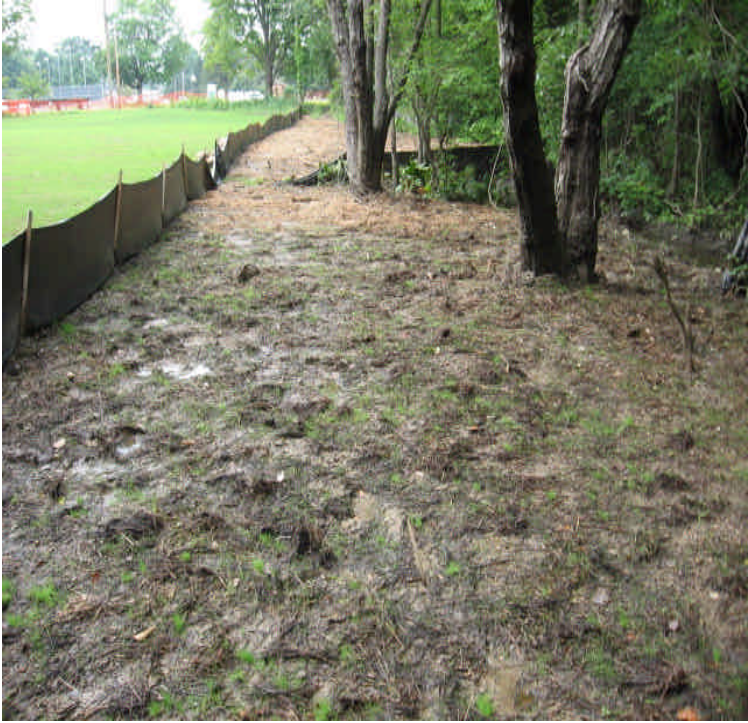
(School Rd HDD) Photo on the left shows the restored wetland area along the site. Standing water in the adjacent wetland was somewhat turbid as a result of the rain. Photo on the right shows the overall yard with increasing grass growth. However, the site is still very wet. 7/5/06

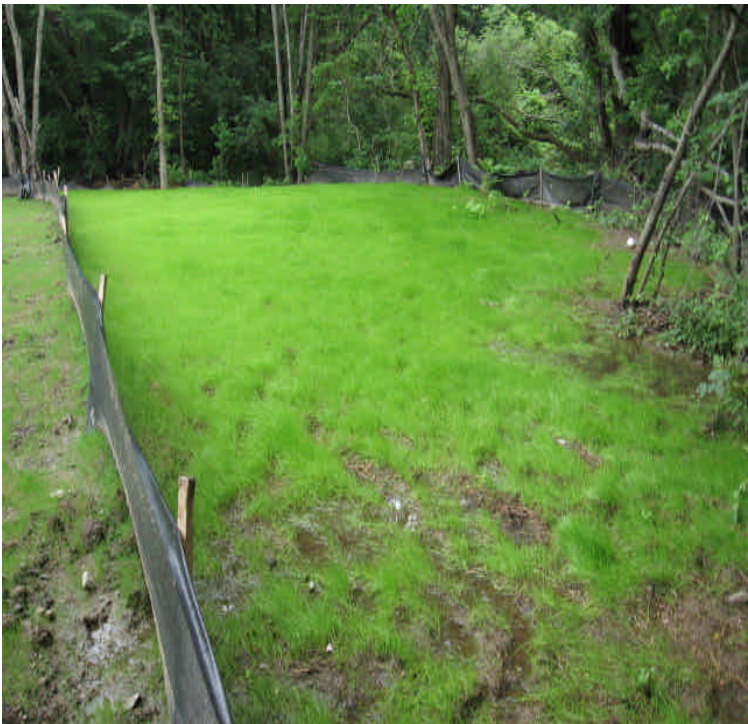
Photo on the left shows significant grass growth in the area adjacent to the wetland channel. Photo on the right shows where a future washout may develop at the silt fence. Continue to monitor and repair/reinforce if necessary. 7/5/06

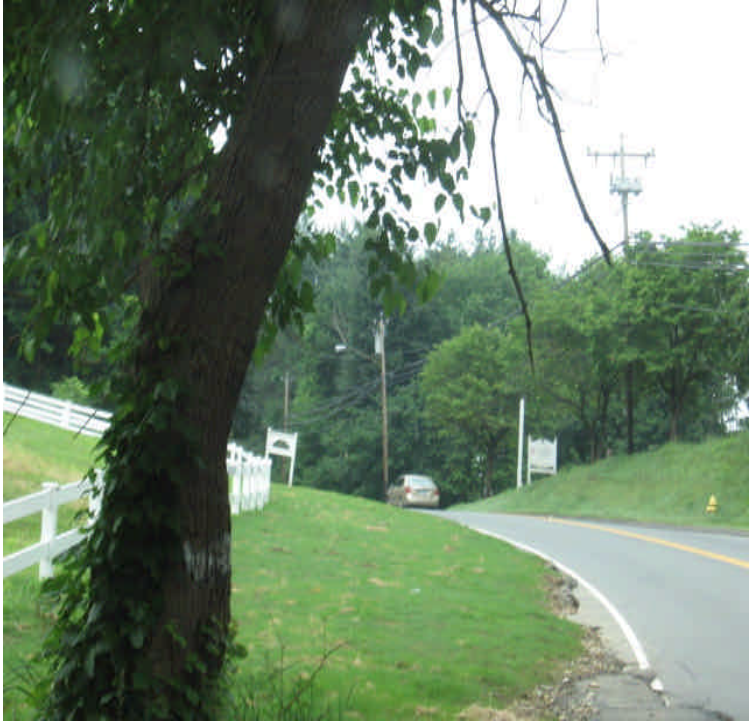
Vegetative clearing limits (including trees to save or danger trees noted)	<ul style="list-style-type: none"> <li>-The restoration efforts (seeding and mulching) near the Zion church on Rt 7 resulted in good grass cover. 7/5/06</li> <li>- The restored area near Wilton HS and Allen Meadow's Park had continued growth. 7/5/06</li> <li>-Vault areas along Umpawaug Rd. will likely be restored soon. 7/5/06</li> <li>-The HDD was hydro-seeded and grass growth was increasing. 7/5/06</li> <li>- New growth continues at the mats near Georgetown Deli. 7/5/06</li> <li>- Some restoration was noted along Rt 7 near Ring's End lumber. 7/5/06</li> </ul>	<ul style="list-style-type: none"> <li>-Continue restoration: other projects are ongoing as well making it difficult to coordinate efforts. 3/29-7/5/06.</li> <li>- Monitor for stabilization. 7/5/06</li> <li>-Restore where necessary after vault access. 5/10-7/5/06</li> <li>-Monitor for final stabilization. 7/5/06</li> <li>-Continue to monitor for final stabilization. 7/5/06</li> <li>- Continue to monitor. 7/5/06</li> </ul>	<ul style="list-style-type: none"> <li>Restoration efforts were successful.</li> <li>-Grass growth was noted</li> <li>-Topsoil delivery was noted</li> <li>- Grass was growing</li> <li>- N/A</li> <li>- N/A</li> </ul>

(Rt 7) Photo on the left shows a recently restored area near the Zion Church along Rt 7 with good grass growth. (New HDD) Photo on the right shows the bore pit internal to the site. 7/5/06

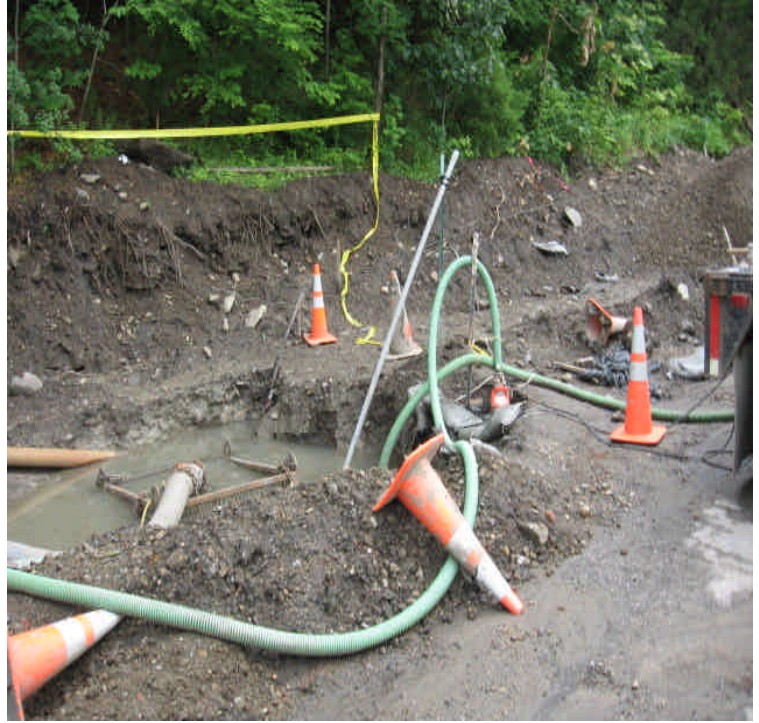
- Drilling equipment is in place at the new HDD site in Georgetown and boring within the excavated pit is ongoing. 6/29-7/5/06	- A bermed asphalt pad remains in place to contain equipment in the reclamation site. Continue	- N/A

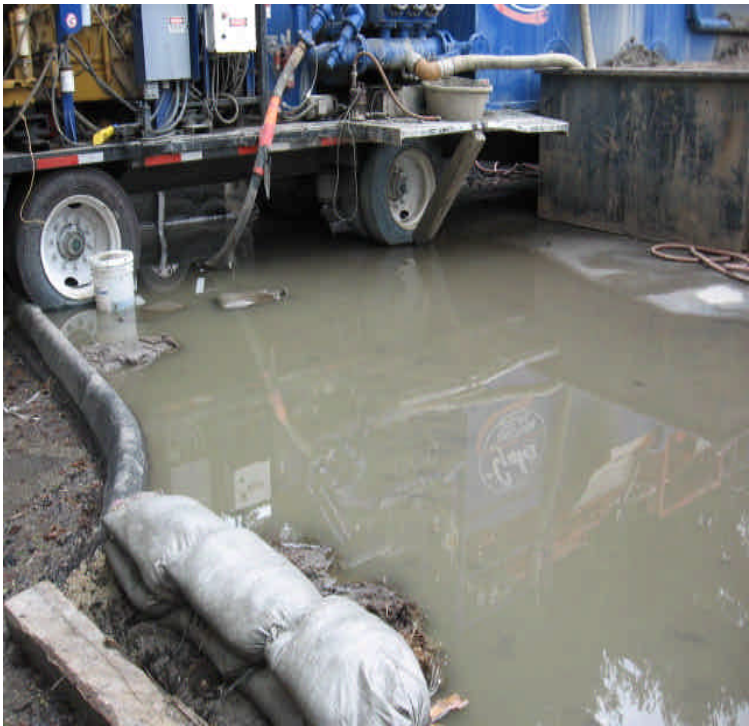
Dewatering	- Dewatering was occurring at the new HDD. Water from the well point was being directed to a frac tank. Some run-off has	- Continue to provide controls. The frac tank is necessary here due to past use of the site although water is fairly clear 7/5/06	- N/A

Photo on the left shows how the asphalt berm is retaining pooled stormwater run-off from the site. A baker tank is also being used. (Georgetown Deli) Photo on the right shows the restored stream bank with increasing vegetative cover. 7/5/06
